Legionella Risk Assessment

11
Grampian Court
AVIEMORE
PH22 1TB

Assessor name: Mr. Martin Anderson
Reference: 000021
Assessment date: 23/09/2022
Property type: Flat

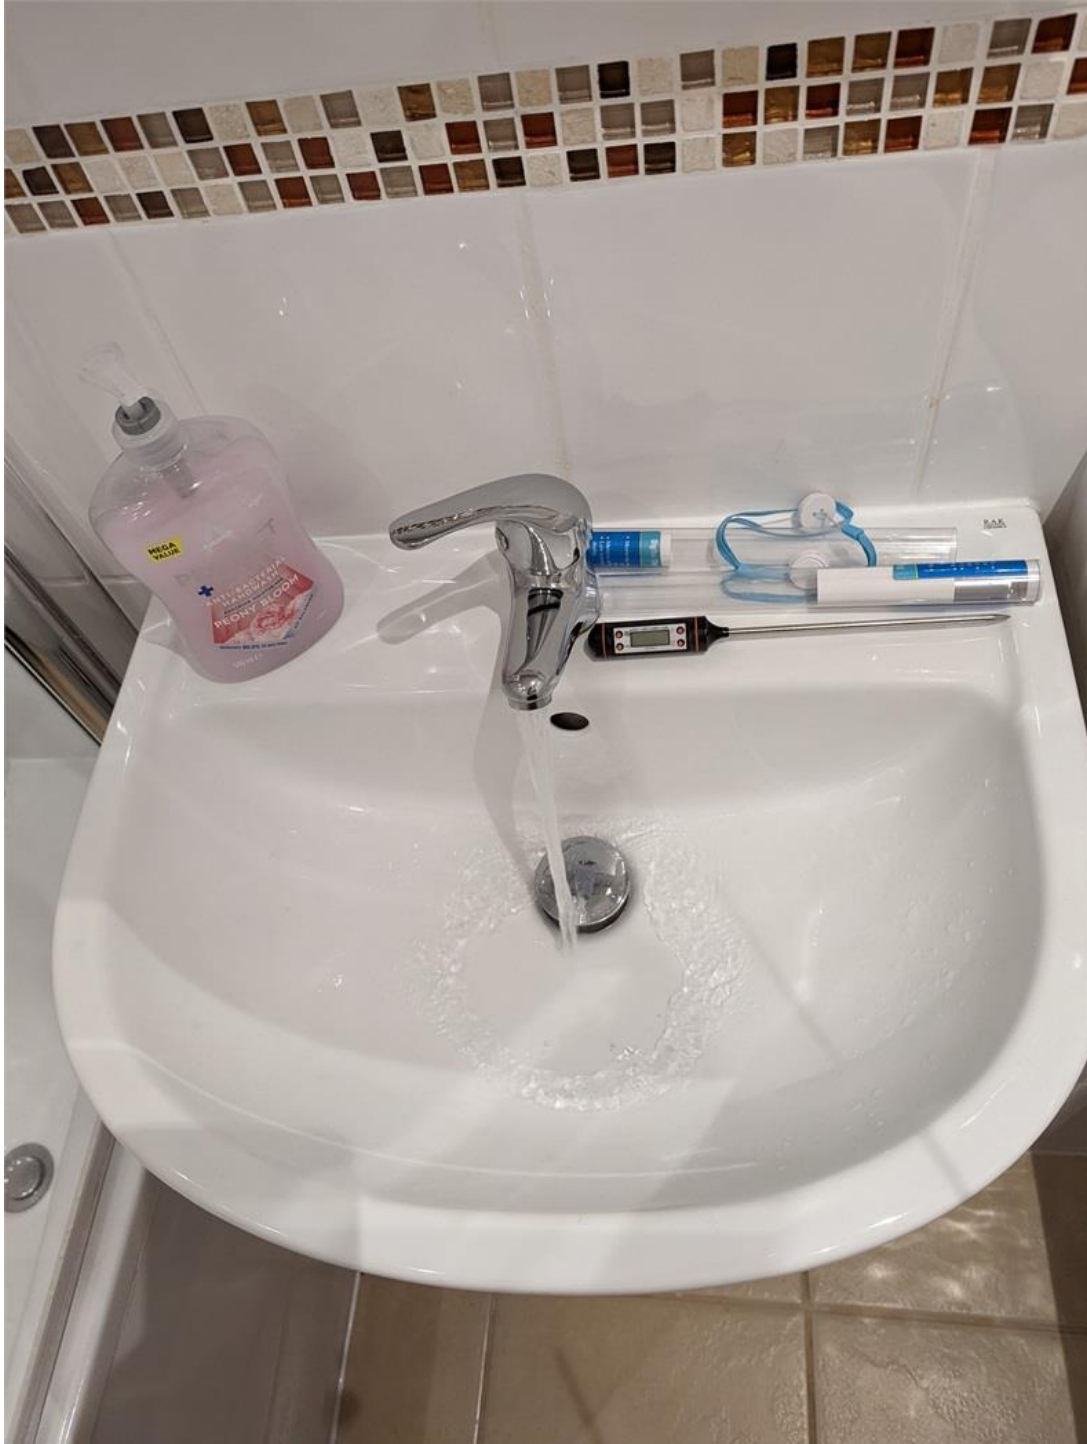
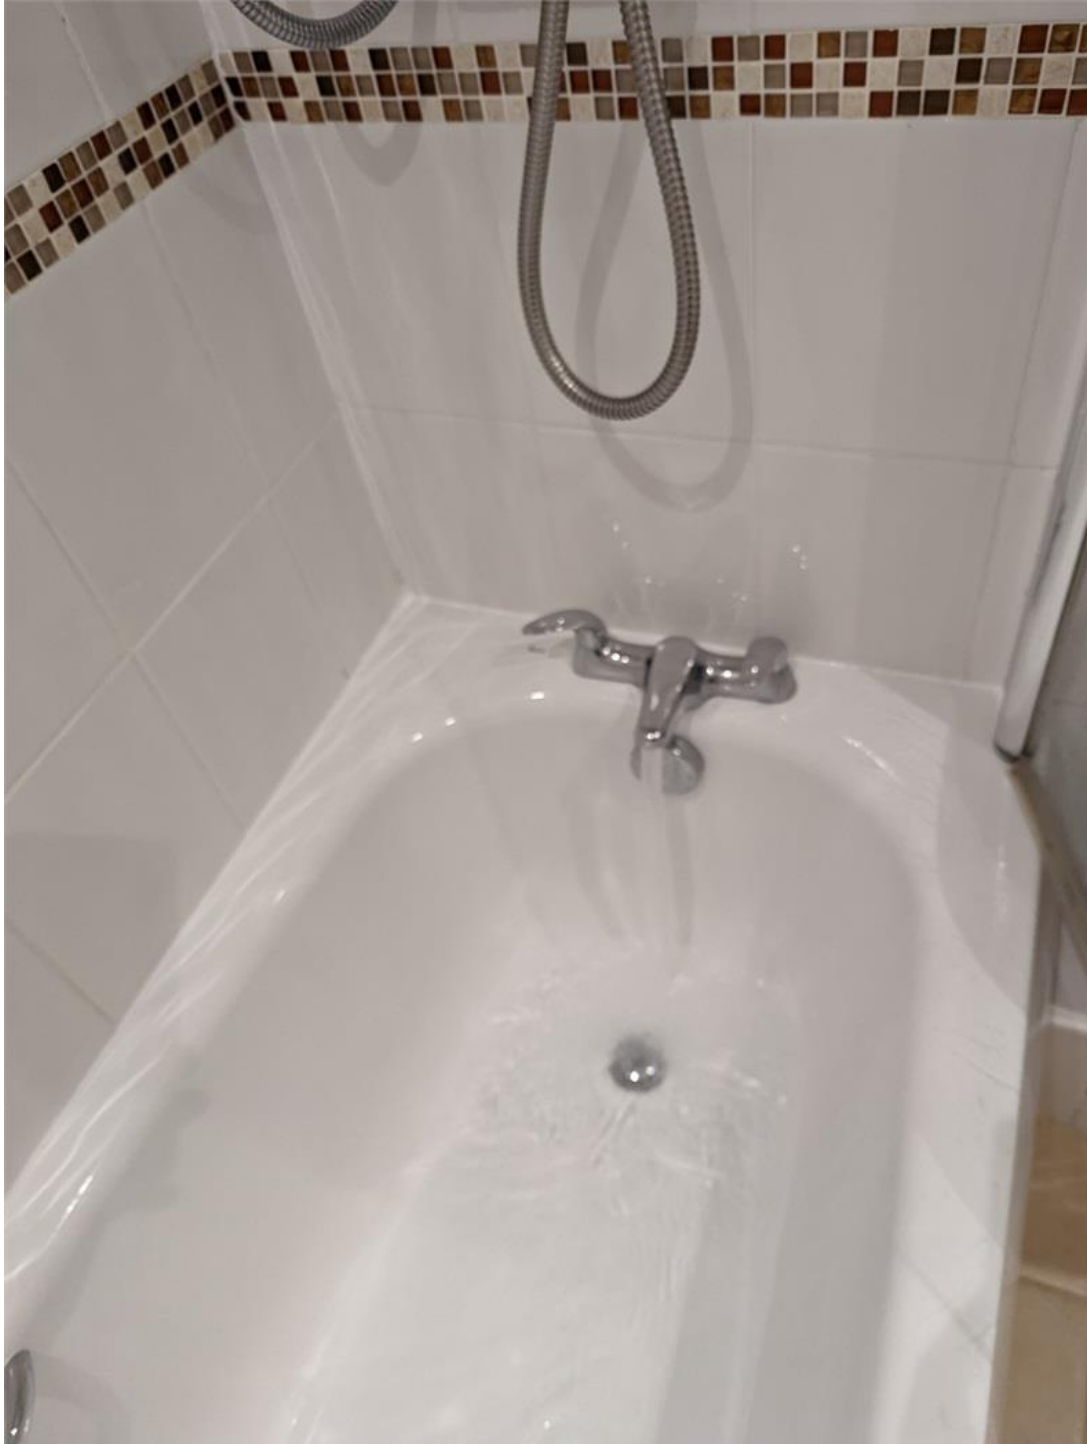
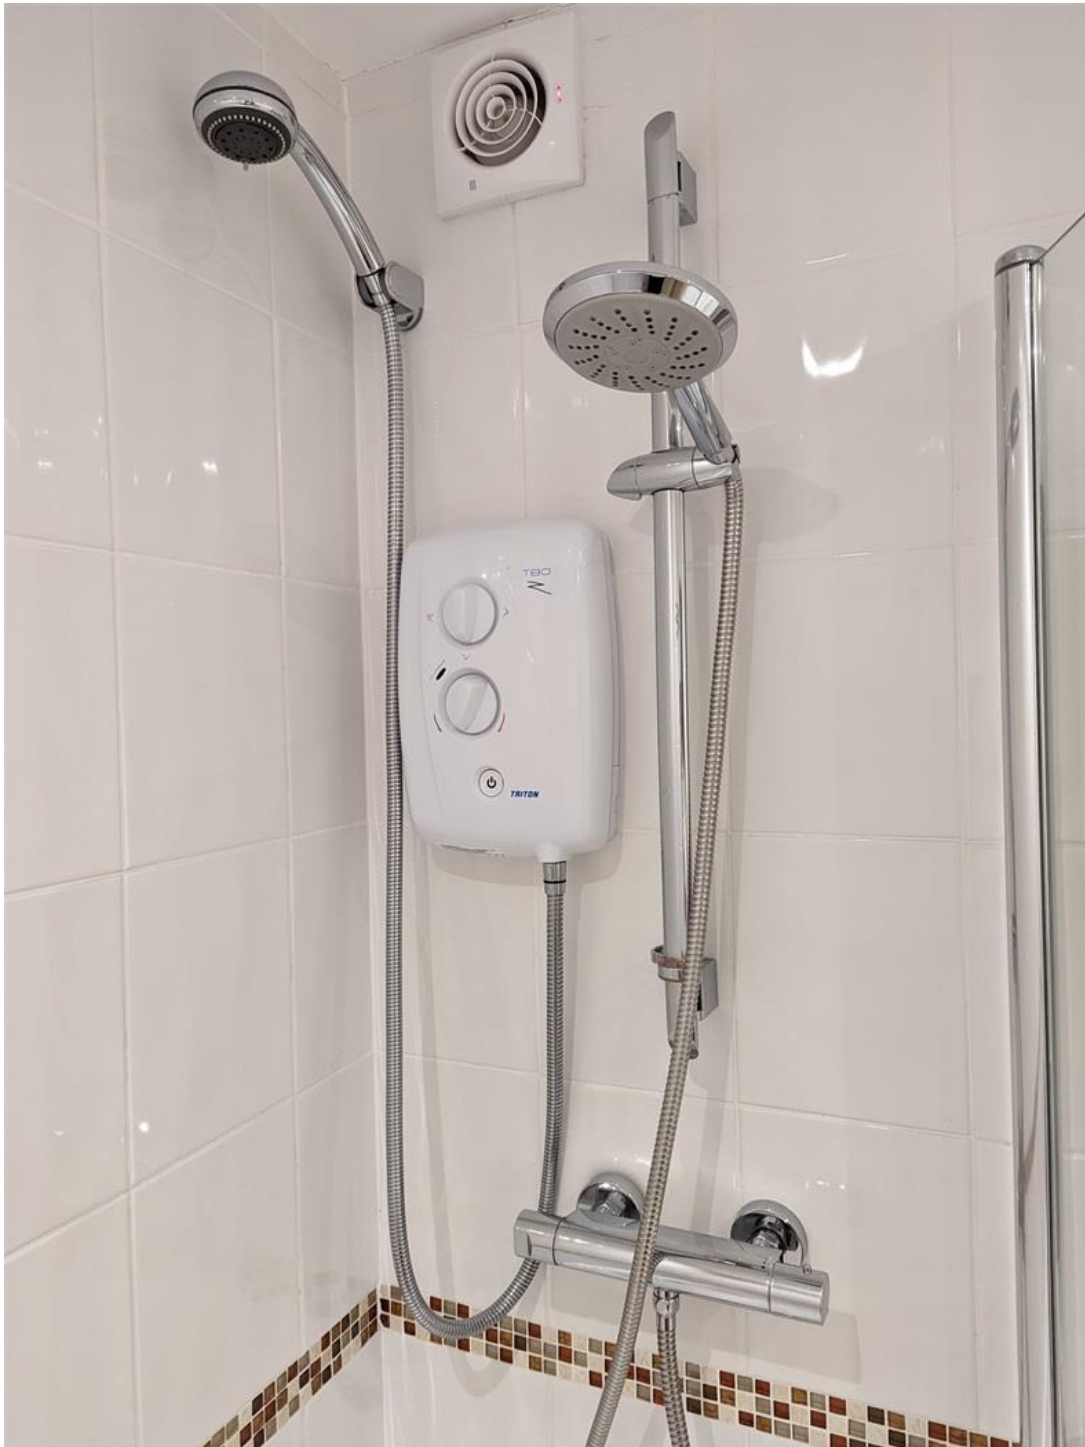
1. Water temperature at outlets
<p>Is cold water temperature below 20°C? Yes</p> <p>Highest recorded temperature (°C) 12</p> <p>Is hot water temperature above 50°C at outlets? Yes</p> <p>Lowest recorded temperature(°C) 60</p> <p>Are TMV's present? No</p> <p>Is hot water temperature from TMVs (if fitted) 39-43°C at outlet(s)? N/A</p>
Issue(s) identified/comments
Cold and Hot temperatures regular throughout property
Risk rating
Risk level 1 - Minor
Recommendation(s)
Photo of water outlet

Ensure boiler/water heater is set to 60°C so that water reaches outlets at above 50°C. Ensure cold water does not exceed 20°C by making sure pipes and storage tanks are insulated. Ensure water temperature at outlets is 39-43°C where TMVs are fitted, or above 50°C at the hot pipe feeding the TMV if it is accessible. TMVs should be tested at least annually.

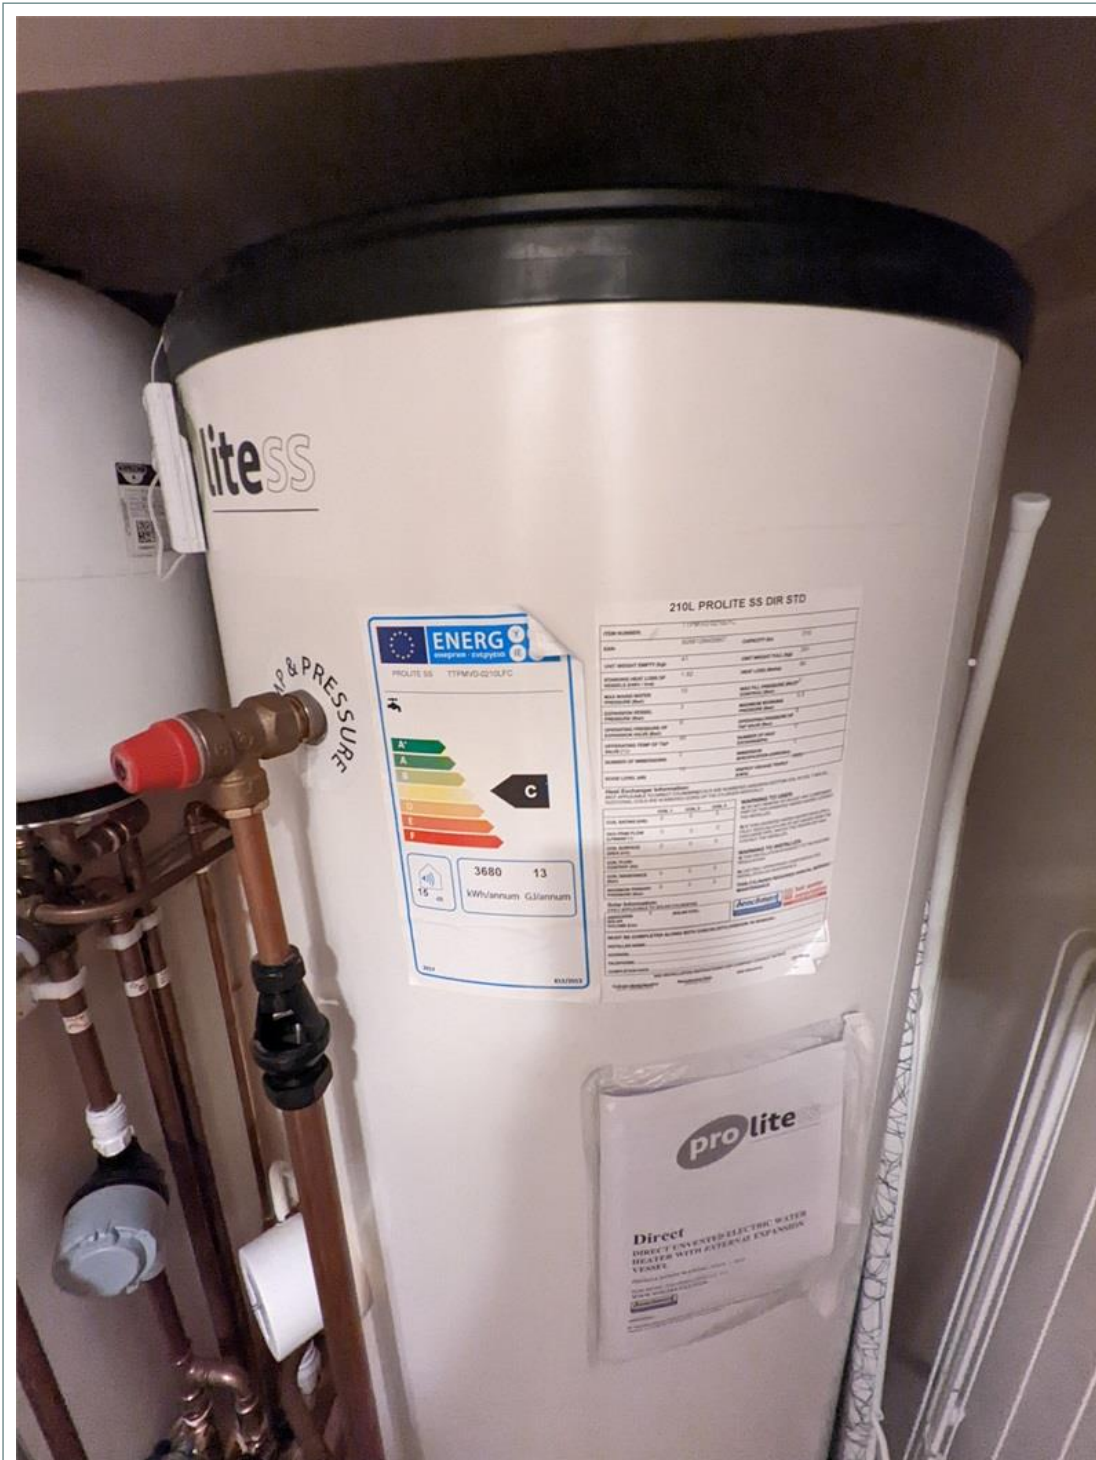
3. Hot water storage
<p>Is a hot water cylinder present? Yes</p> <p>Is the cylinder insulated? Yes</p> <p>Is a cylinder thermostat present? Yes</p> <p>Is the temperature on the cylinder thermostat set to 60°C or above? Yes</p> <p>Is the temperature of the flow pipe 60°C or above? Yes</p> <p>Is the temperature of the return pipe 50°C or above?(recirculating systems only) N/A</p> <p>Does the overflow from the calorifier go to a tundish or drain? N/A</p> <p>Does the storage vessel comply with relevant HSE guidance? Yes</p>
Issue(s) identified/comments
Modern, well maintained Hot Water Tank
Risk rating
Risk level 1 - Minor
Recommendation(s)
Photo of hot water storage

Ensure hot water is stored at 60°C. The cylinder should be insulated to help maintain the correct temperature and to prevent heat loss. If a cylinder thermostat is fitted it should be set at the correct temperature and not adjusted. The overflow from a cylinder should go directly to a tundish or drain, not back into the cold water tank.

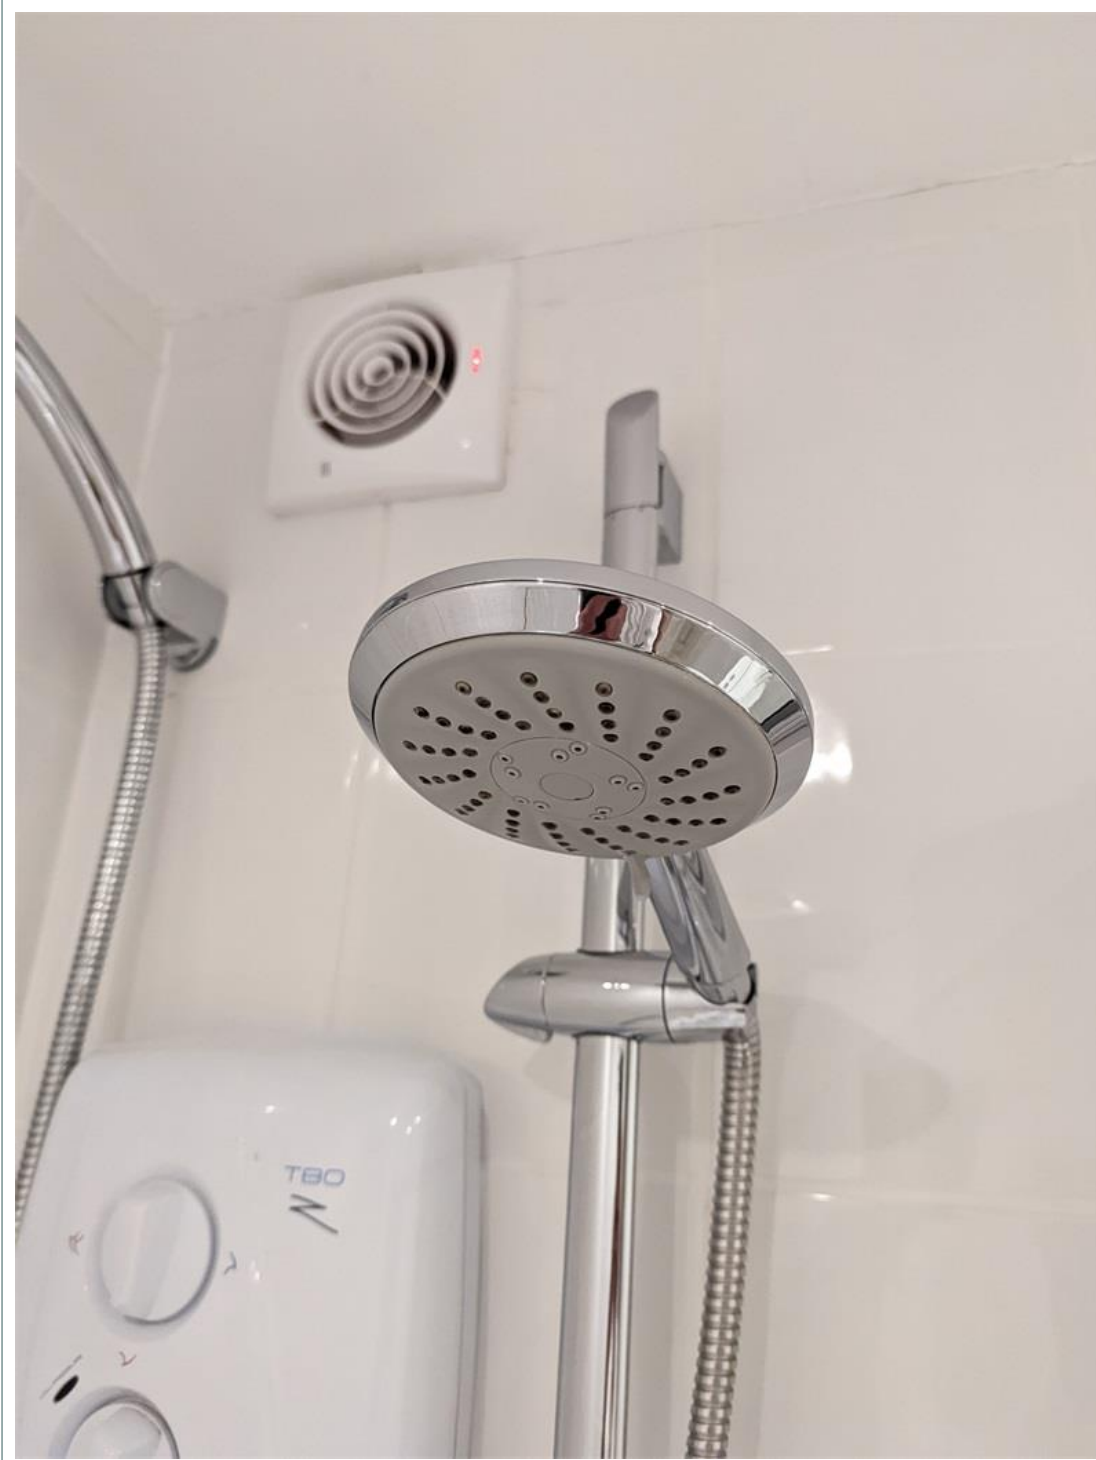
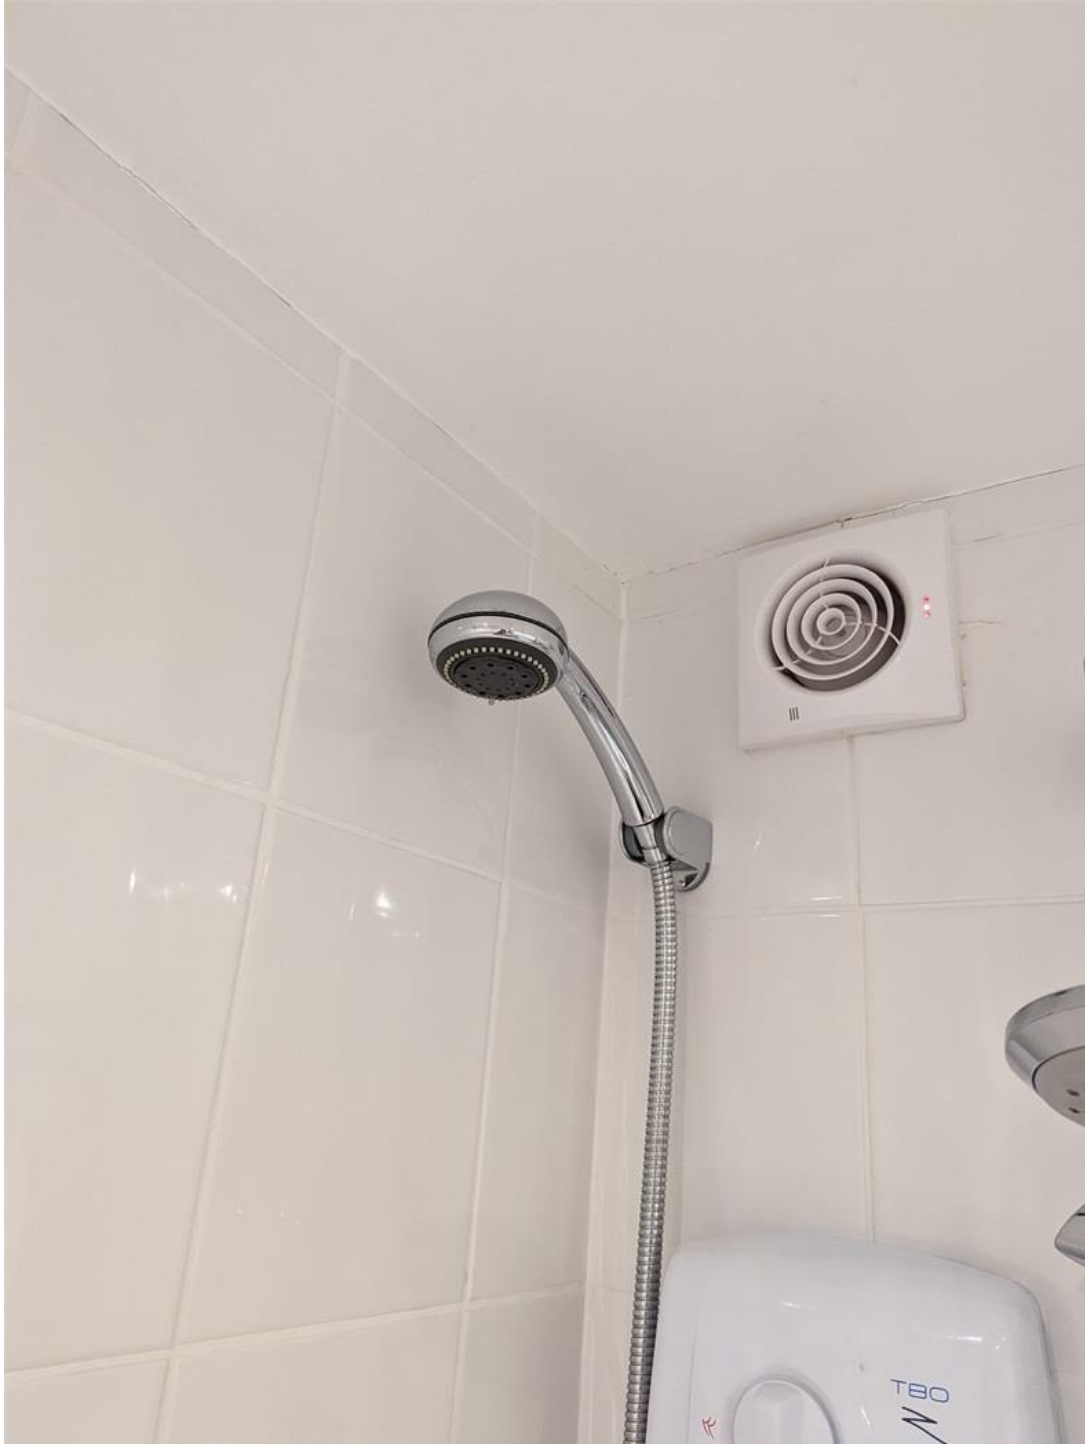
5. Shower heads, taps and other spray outlets
<p>Are there any showers present? Yes</p> <p>Are there any spray taps present? No</p> <p>Is there a hose pipe present? No</p>
Issue(s) identified/comments
Electric shower and Shower hear from taps. Both very clean and well-maintained
Risk rating
Risk level 1 - Minor
Recommendation(s)
Photo of Shower heads, taps and other spray outlets

Any showers/spray/taps/hose pipes should be flushed through weekly. Shower heads and other outlets should be de-scaled at least every 3-6 months. Consideration should be given to replacing spray taps with normal taps.
