Legionella Risk Assessment

8
Grampian Court
AVIEMORE
PH22 1TB

Assessor name: Mr. Martin Anderson
Reference: 000020
Assessment date: 23/09/2022
Property type: Flat

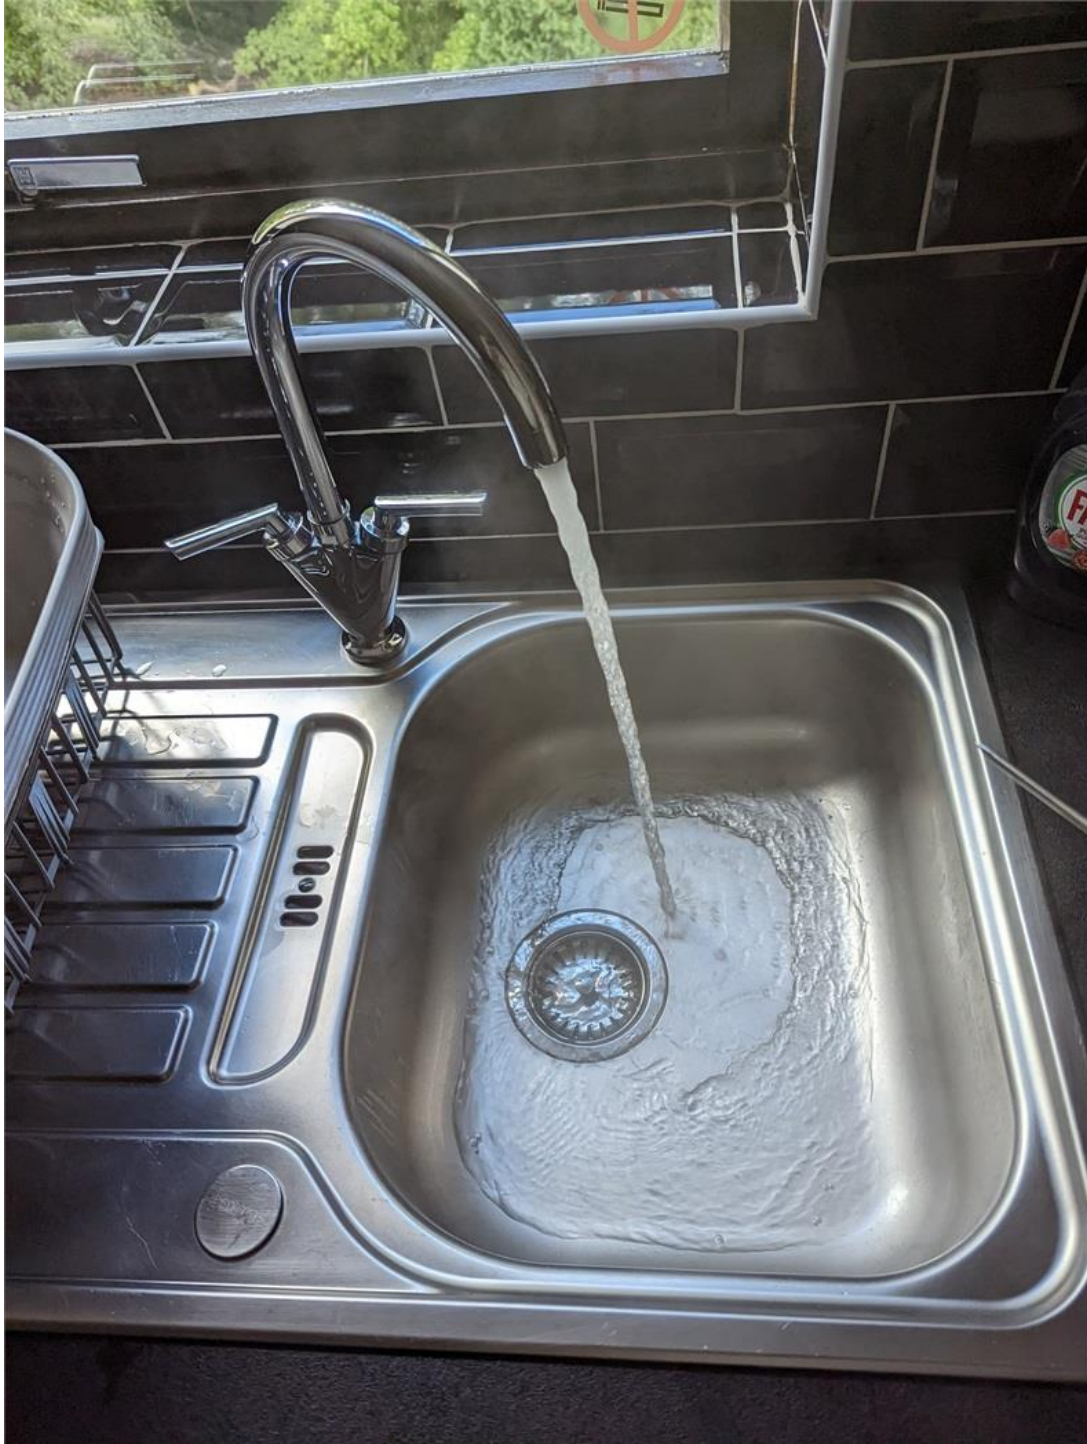
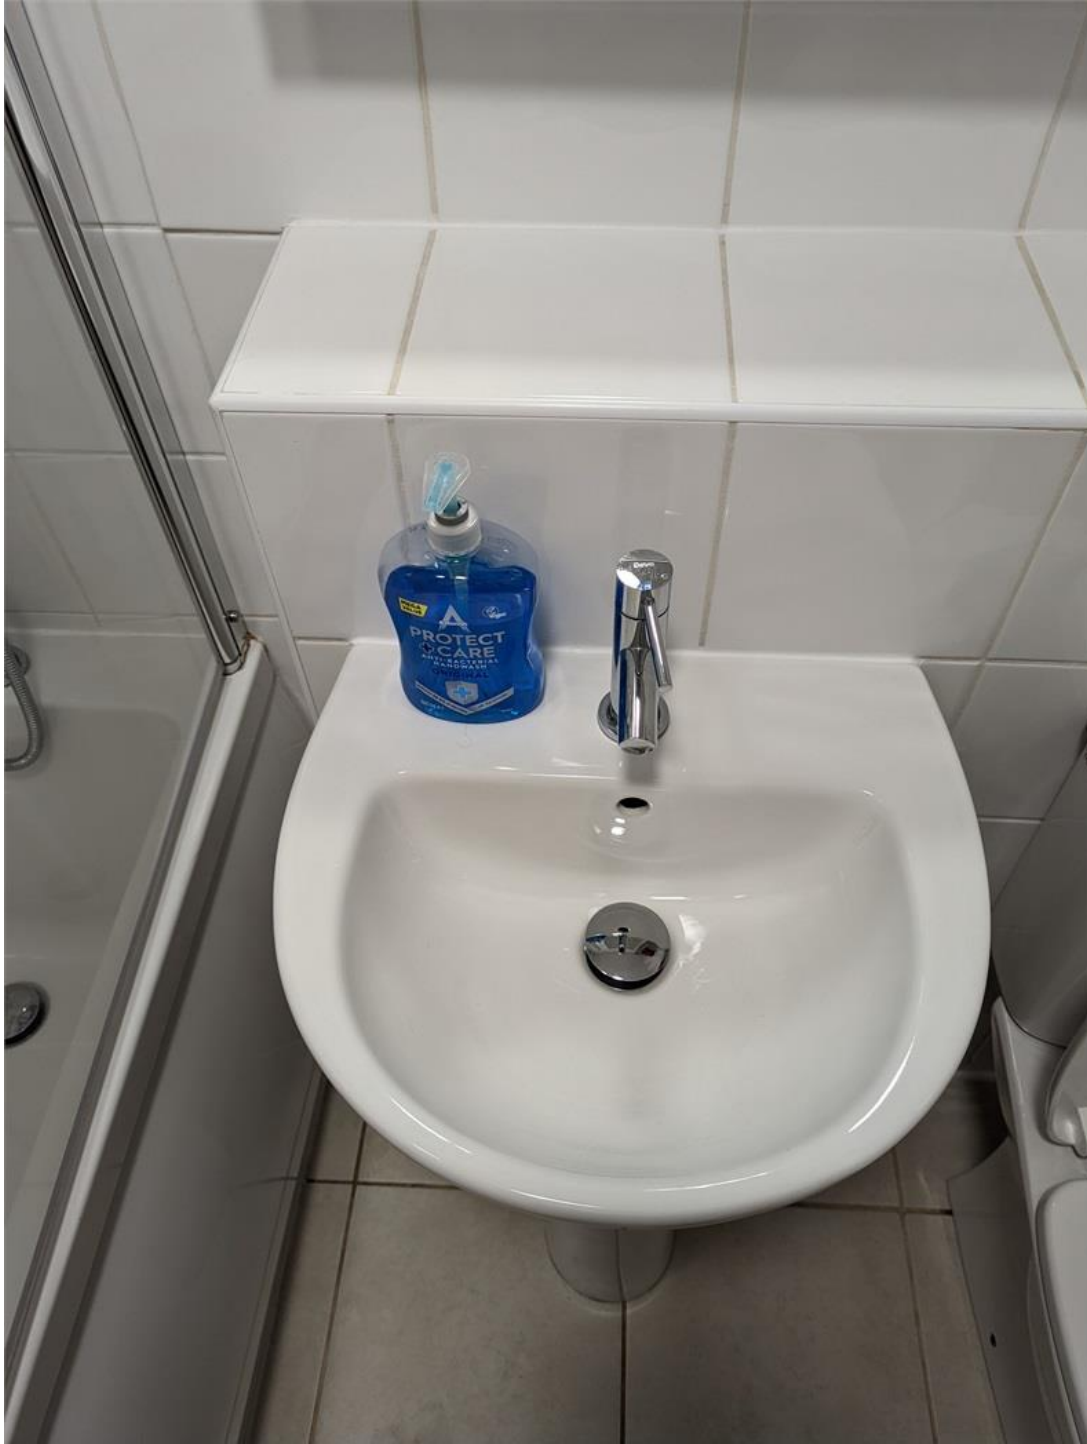
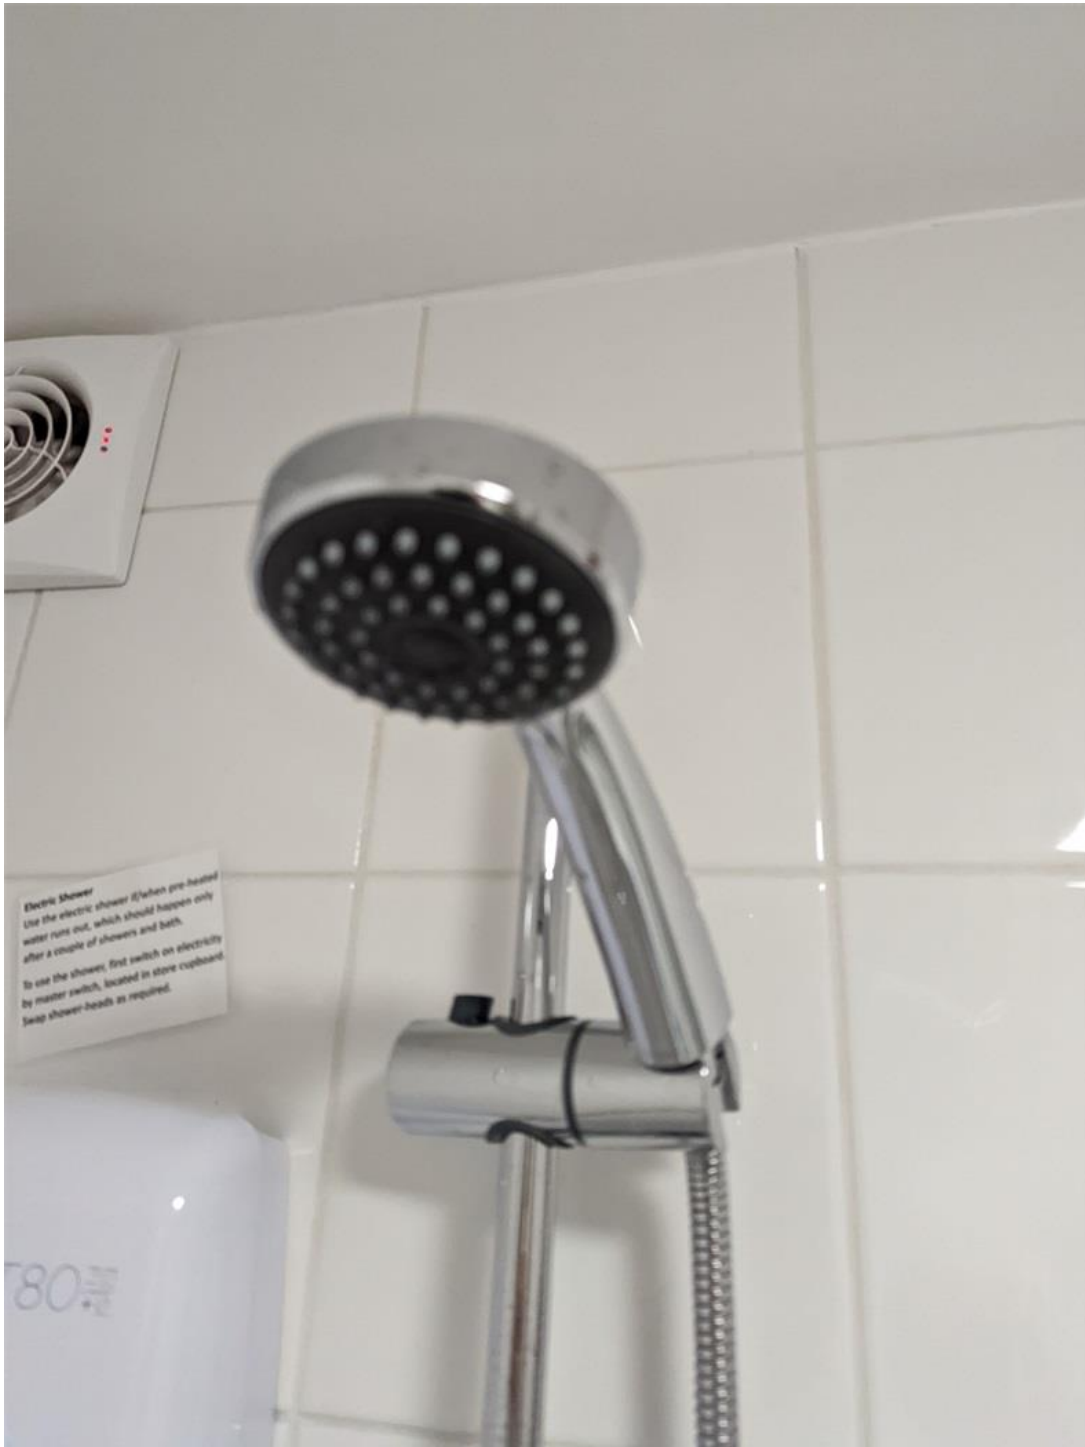
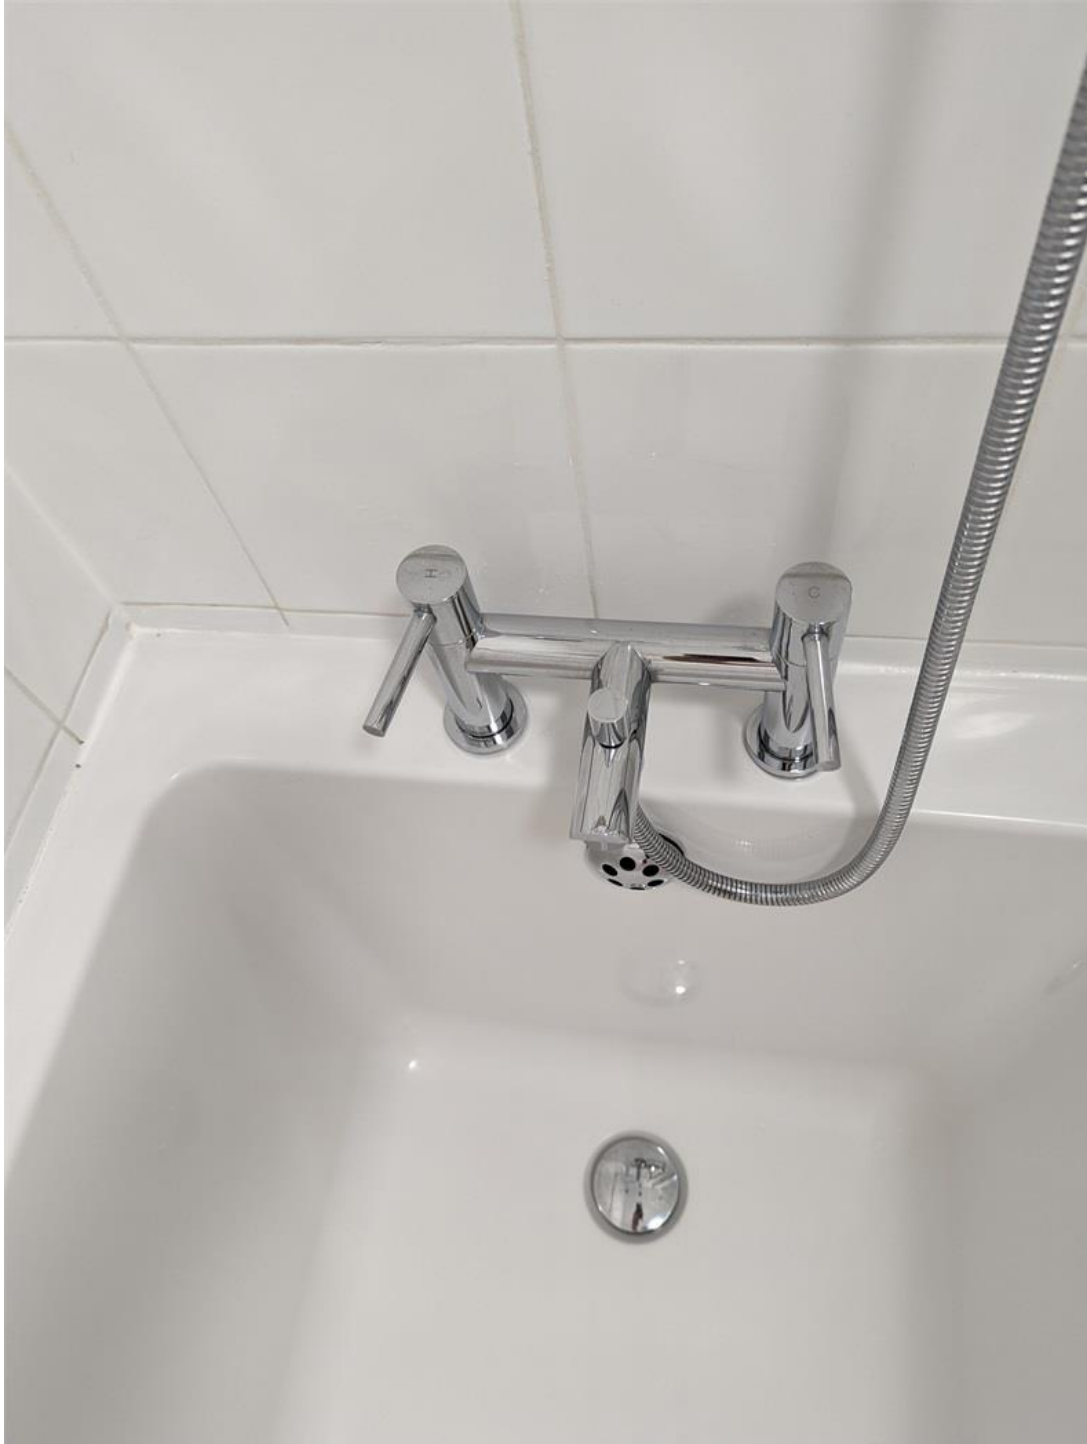
1. Water temperature at outlets
<p>Is cold water temperature below 20°C? Yes</p> <p>Highest recorded temperature (°C) 12</p> <p>Is hot water temperature above 50°C at outlets? Yes</p> <p>Lowest recorded temperature(°C) 65</p> <p>Are TMV's present? No</p> <p>Is hot water temperature from TMVs (if fitted) 39-43°C at outlet(s)? N/A</p>
Issue(s) identified/comments
Cold and Hot temperatures regular throughout property
Risk rating
Risk level 1 - Minor
Recommendation(s)
Photo of water outlet

Ensure boiler/water heater is set to 60°C so that water reaches outlets at above 50°C. Ensure cold water does not exceed 20°C by making sure pipes and storage tanks are insulated. Ensure water temperature at outlets is 39-43°C where TMVs are fitted, or above 50°C at the hot pipe feeding the TMV if it is accessible. TMVs should be tested at least annually.

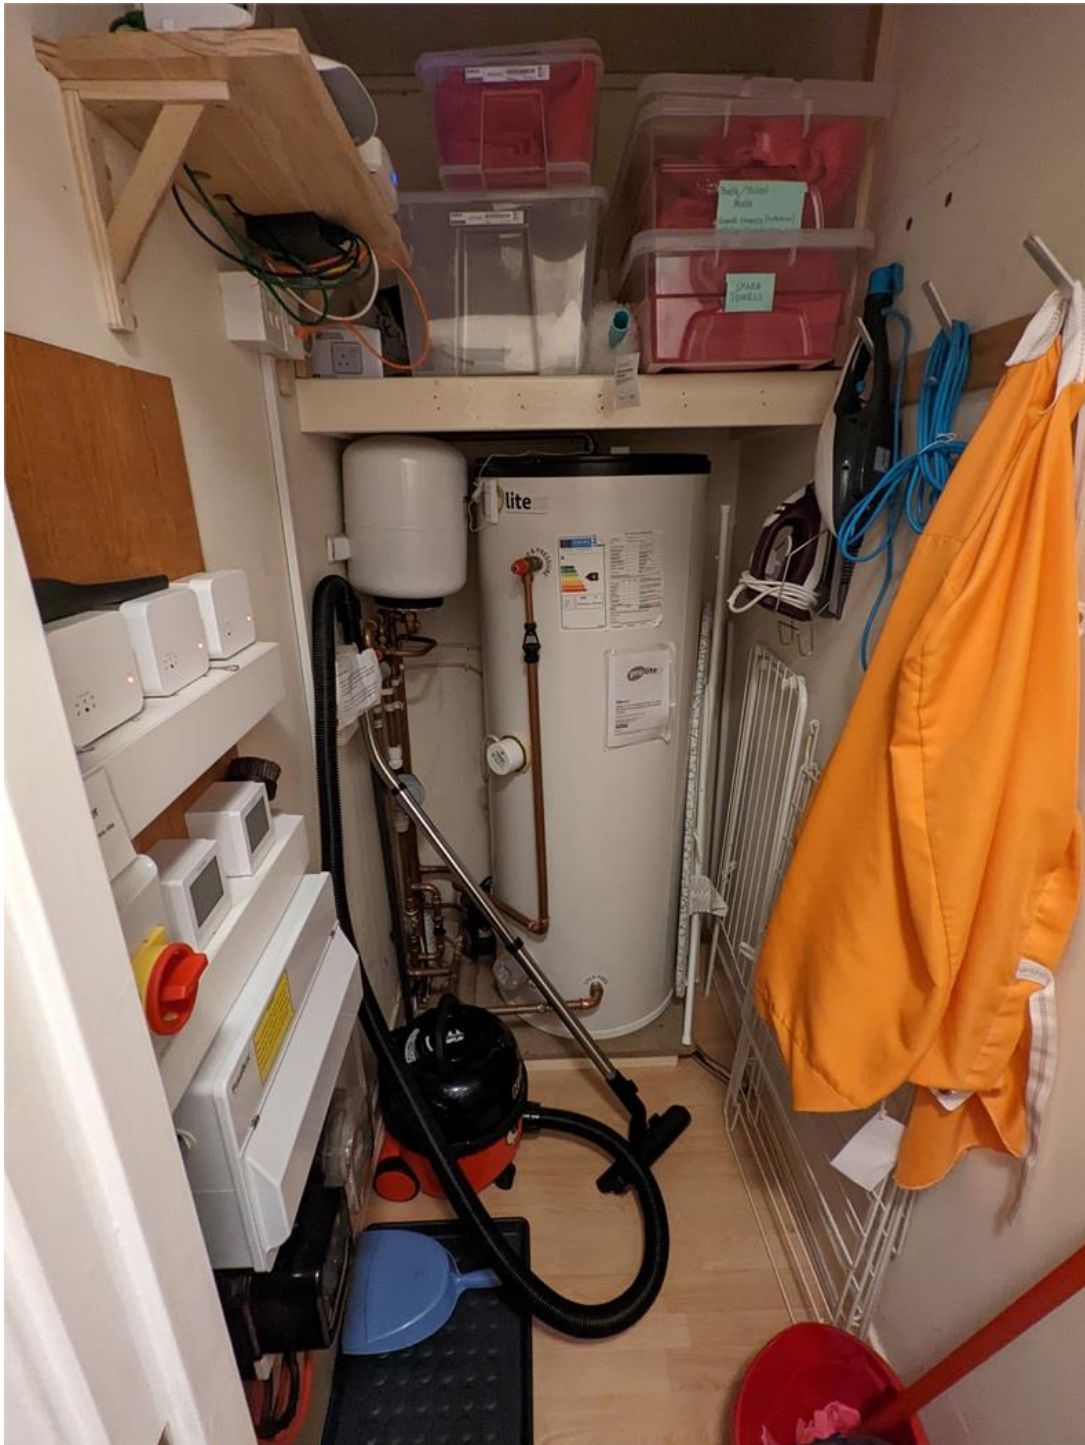
3. Hot water storage
<p>Is a hot water cylinder present? Yes</p> <p>Is the cylinder insulated? Yes</p> <p>Is a cylinder thermostat present? Yes</p> <p>Is the temperature on the cylinder thermostat set to 60°C or above? Yes</p> <p>Is the temperature of the flow pipe 60°C or above? Yes</p> <p>Is the temperature of the return pipe 50°C or above?(recirculating systems only) N/A</p> <p>Does the overflow from the calorifier go to a tundish or drain? N/A</p> <p>Does the storage vessel comply with relevant HSE guidance? Yes</p>
Issue(s) identified/comments
Modern, well maintained Hot Water Tank
Risk rating
Risk level 1 - Minor
Recommendation(s)
Photo of hot water storage

Ensure hot water is stored at 60°C. The cylinder should be insulated to help maintain the correct temperature and to prevent heat loss. If a cylinder thermostat is fitted it should be set at the correct temperature and not adjusted. The overflow from a cylinder should go directly to a tundish or drain, not back into the cold water tank.

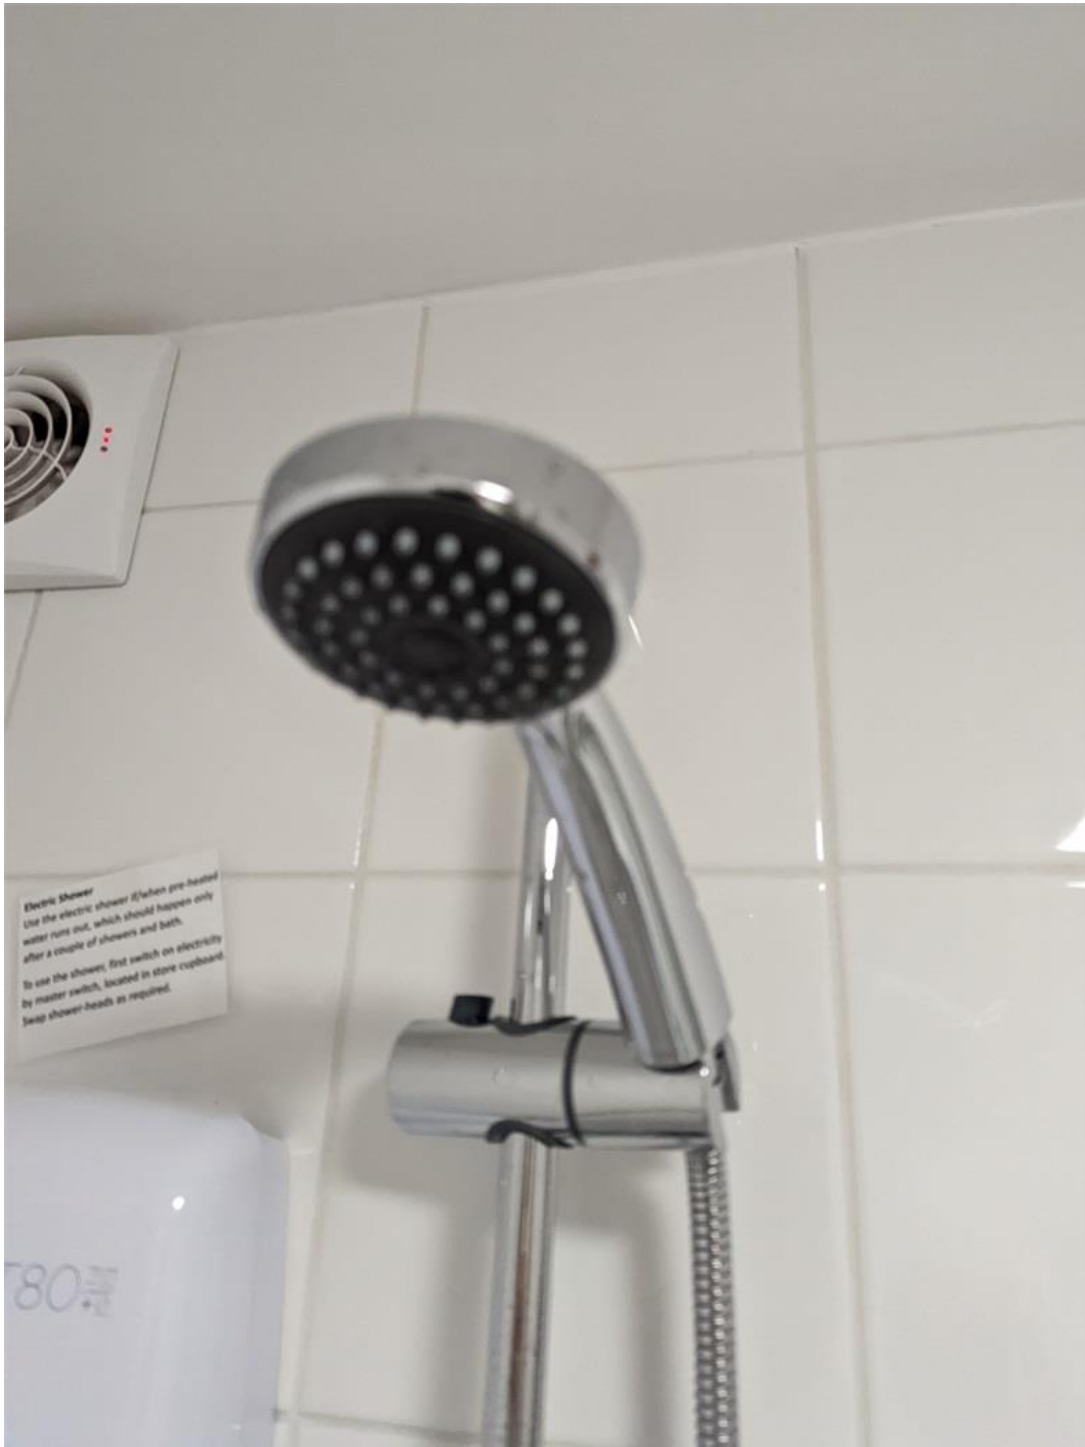
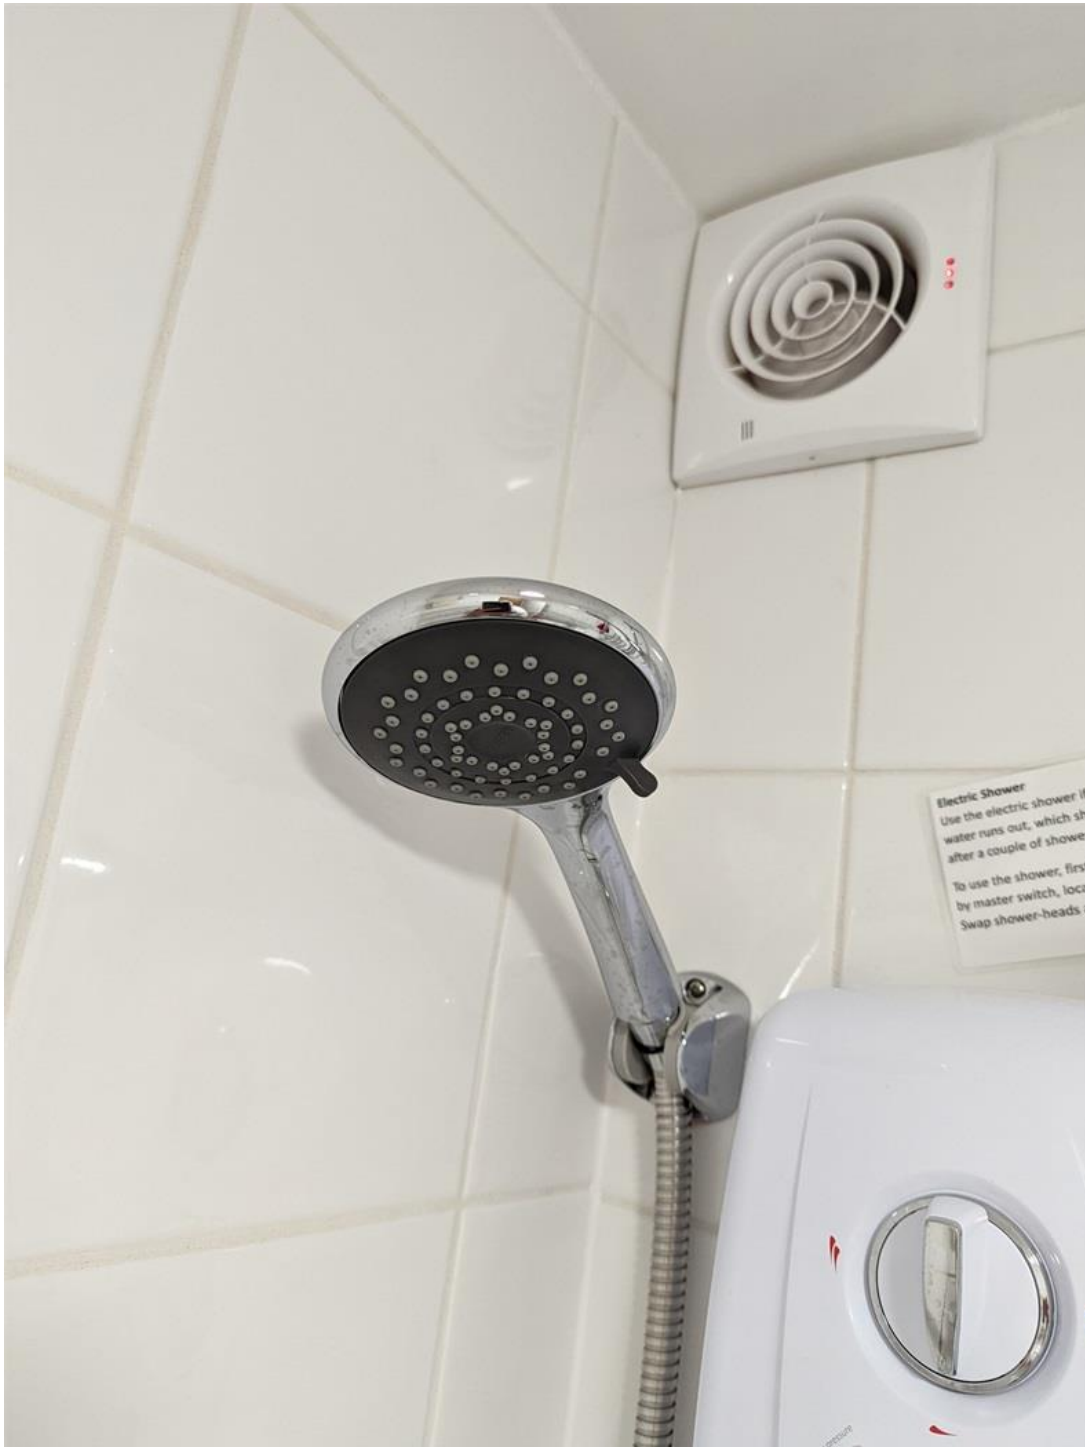
5. Shower heads, taps and other spray outlets
<p>Are there any showers present? Yes</p> <p>Are there any spray taps present? No</p> <p>Is there a hose pipe present? No</p>
Issue(s) identified/comments
Electric shower and Shower hear from taps. Both very clean and well-maintained
Risk rating
Risk level 1 - Minor
Recommendation(s)
Photo of Shower heads, taps and other spray outlets

Any showers/spray/taps/hose pipes should be flushed through weekly. Shower heads and other outlets should be de-scaled at least every 3-6 months. Consideration should be given to replacing spray taps with normal taps.
